Report to Sunman-Dearborn Community Schools Board of Trustees

Existing Facility Conditions Analysis + Improvement Plan

10-05-2023

SUNMAN-DEARBORN COMMUNITY SCHOOLS

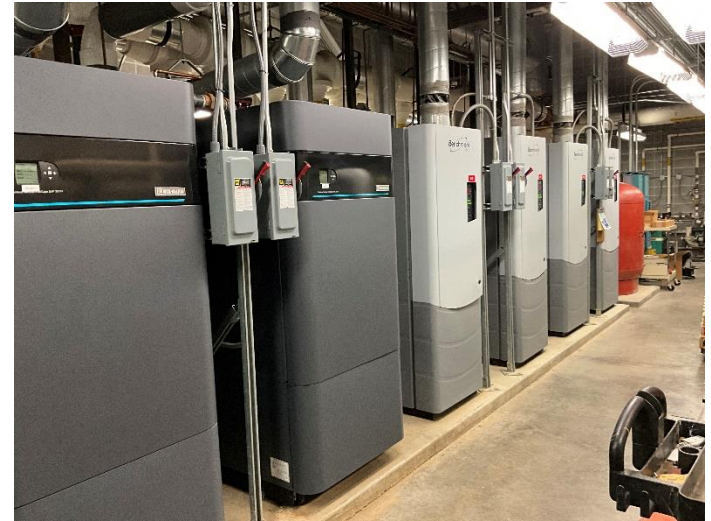
The building is heated by means of (2) Weil-McLain SVF 2000 boilers and (4) Aerco Benchmark 2.0 boilers. The Weil-McLain boilers were installed in 2022 and are in good condition. The Aerco boilers are 18 years old and are in fair condition generally speaking however it is known that one of the existing units has a cracked heat exchanger and the others are likely to fail in the near future. Given that two of these Aerco boilers have been replaced by the Weil-McLain boilers, it would be recommended that **the remaining Aerco boilers also be replaced soon.**

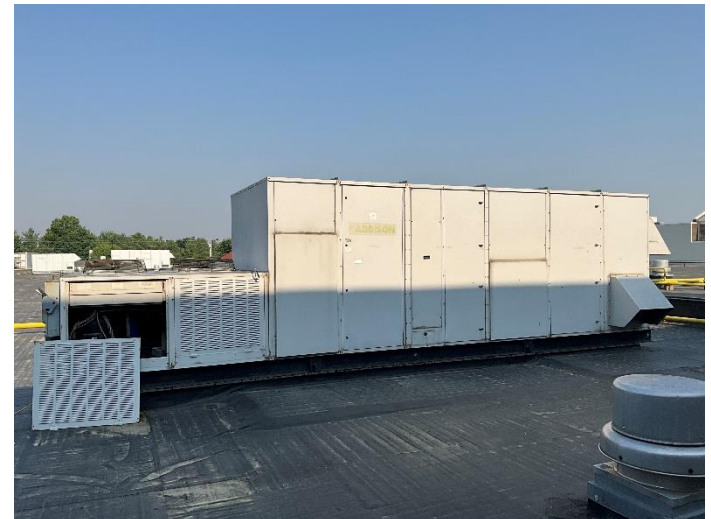
Rooftop units

The building is cooled by means of (33) Addison rooftop units that are approximately 18 years old. According to ASHRAE, the median lifespan of a commercial rooftop unit is 15-20 years. Typically, at 15 years the compressors will start to fail and condenser fans motors will also start to fail. It was observed that in a few cases, new compressors were already installed in some of the units. **Given the age of these units is nearing 20 years, it is strongly recommended to start replacing units in a planned rotation with several every year.**

It was noted that on the newer rooftops that exist, they were not purchased with hail guards on the condenser coils. With the new generation of equipment using a micro-channel style condenser coil, these hail guards are critical to protect the unit from hail stone damage that is capable of breaching the refrigerant circuits and causing leaks. Old style plate fin condensers could take hail abuse and while their performance was degraded, the refrigerant circuit was buried deep within the fins, the new units are no longer this way. It is strongly recommended that all new units come with hail guards and the guards be purchased and added to recently purchased units.

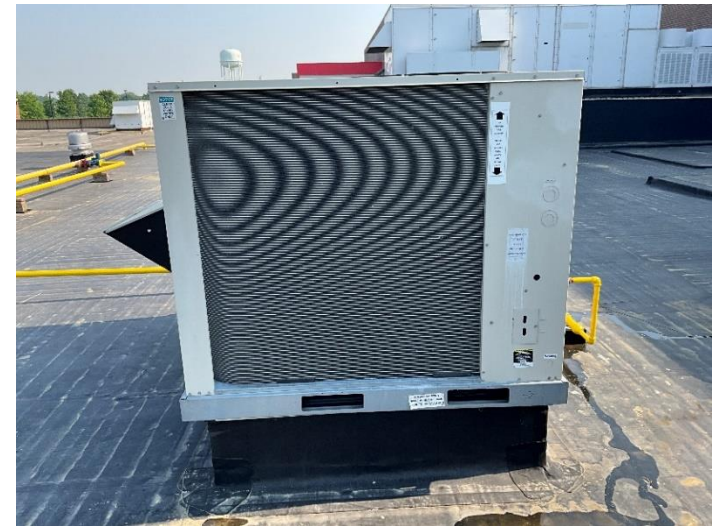
There are 7 rooftop units that are not Addison brand (York, Carrier, Daikin, Trane) that appear to be relatively new and in good condition. These appear to be about 2 years old and in good condition. **There are two carrier units that appear to be older (16 years old) and will most likely need replacement soon.**

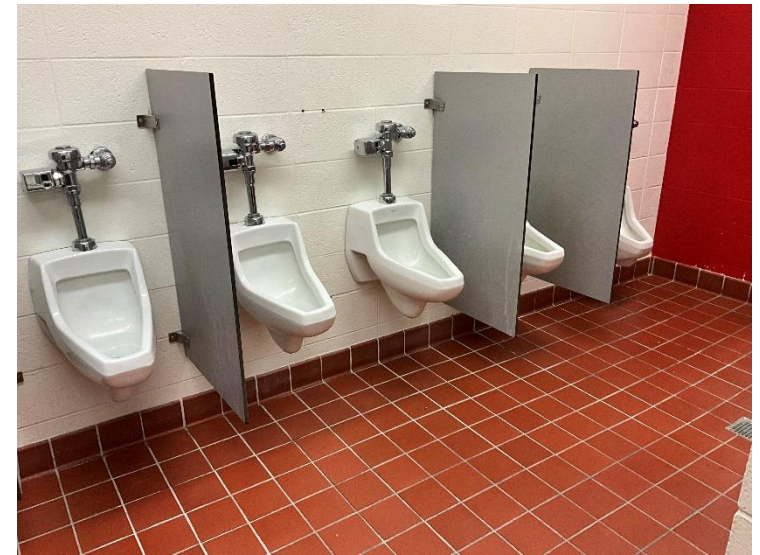
The existing plumbing system consists of a pressure booster system that is in good condition, a water softener, and fairly new water heaters and storage tanks that are all in good condition. The fixtures throughout the building are of various ages and styles. It noted that the age and style of the urinals in men's restrooms were of the type that were popular in the 1960-1970's and generally consume large amounts of water to flush. **It is recommended to replace urinals and water closets to reduce flush rates.** Generally, the water savings cost is not significant, however the real savings occurs on the sanitary waste charges in most municipalities. Payback is generally 3-5 years for heavily used fixtures that see frequent use in a school setting. New water closet fixtures should use 1.28 or 1.5 gpf and urinals should flush at 0.5 gpf.

While it is possible to get urinals with a pint of water per flush, we generally find that in existing buildings with aged cast iron drain pipes, they can be problematic if the pipe holds water and debris with sagging joints and combined with cast iron pipe. What can happen is that the limited amount of water does not fully dilute the urine, and if not fully drained, the water will evaporate out in the pipe and leave the salts from the urine and crystalize in the pipe creating further obstructions.

Prior to replacing water closets in mass, it is recommended to camera inspect the sanitary mains to identify and clear any obstructions before using reduced flow rate fixtures.

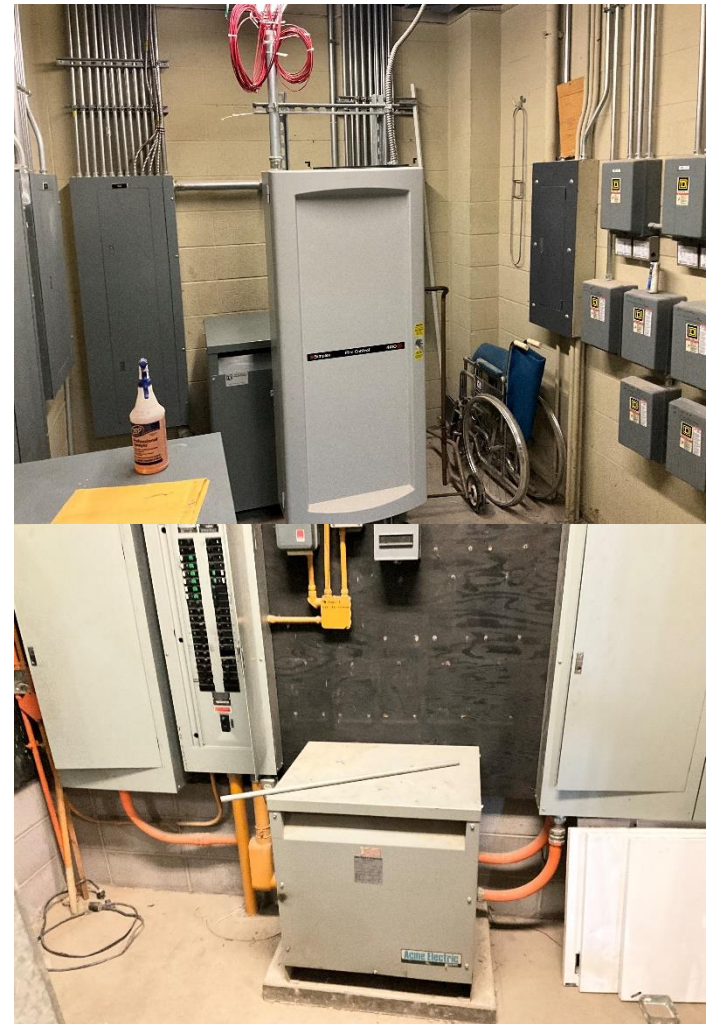
Second Floor Unit J (Mechanical Mezzanine by Gymnasium) Distribution is (1) 400A480/277 Volt 3-phase distribution panels with 400-Amp main circuit breaker that serve branch circuit panels, rooftop units, and dry type transformer. here appears to be sufficient space in the distribution. **The panelboard appears to be part of the original service entrance and are beyond their serviceability and should be consider for replacement.**

The Main telecom distribution system has a small single-phase residential style engine-generator and transfer switch that serves the space that has been installed in recent years. It appears to be in good condition.

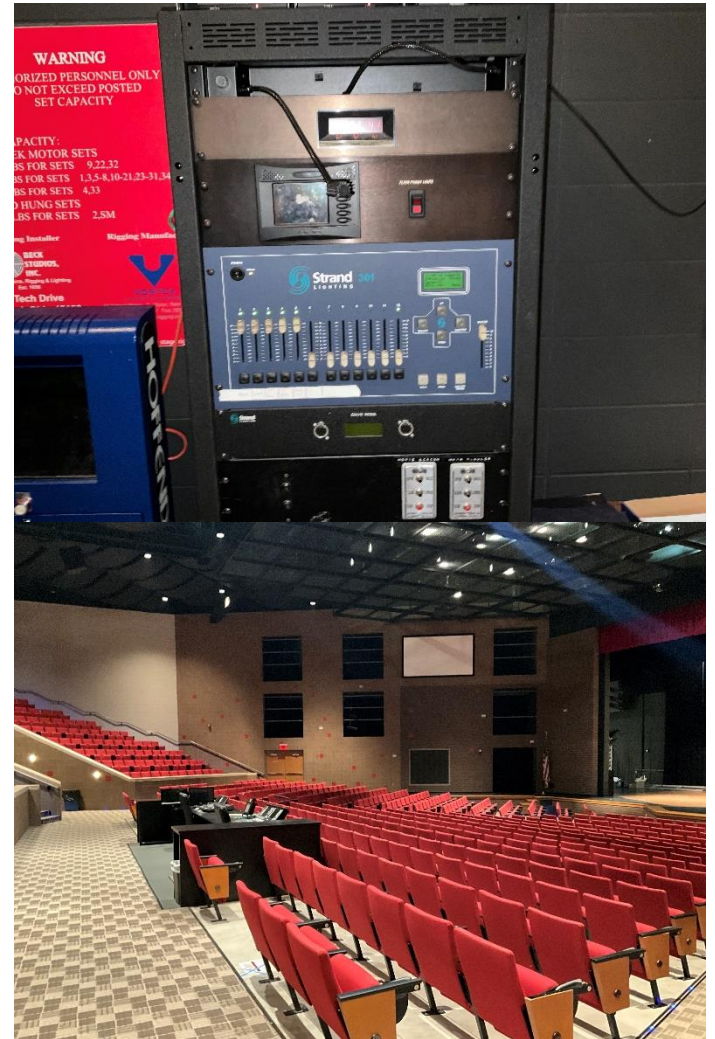
Auditorium Lighting

The existing auditorium lighting appear to be original to the building (completed in 2006). The lighting consists of incandescent for both house lighting and theatrical lighting. The theatrical dimming system appears to be original as well and is **outdated to today standard and is at the end of its useful life.**

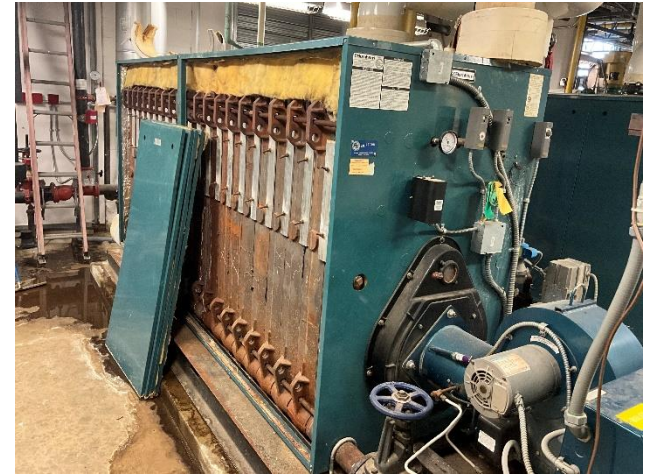
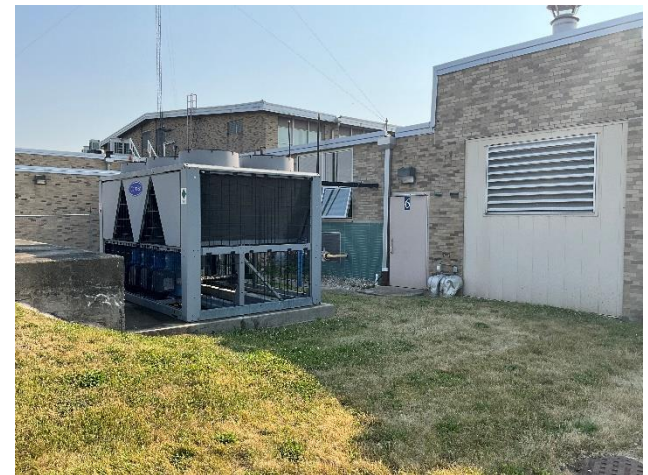
The heating plant consists of (2) Burnham 4,174 MBH cast-iron sectional boilers, (2) Taco base mounted centrifugal house pumps, (2) Taco in-line centrifugal boiler pumps, expansion tank, and air separator that are aged and in poor condition. **It is recommended that the heating plant be replaced.**

The cooling plant consists of (1) Carrier air-cooled scroll chiller with remote evaporator barrel, in-line centrifugal chiller pump, expansion tank, and air-separator. The system was recently upgraded and is in good condition. No improvements are recommended.
