Report to Sunman-Dearborn Community Schools Board of Trustees

Existing Facility Conditions Analysis + Improvement Plan

10-05-2023

SUNMAN-DEARBORN COMMUNITY SCHOOLS

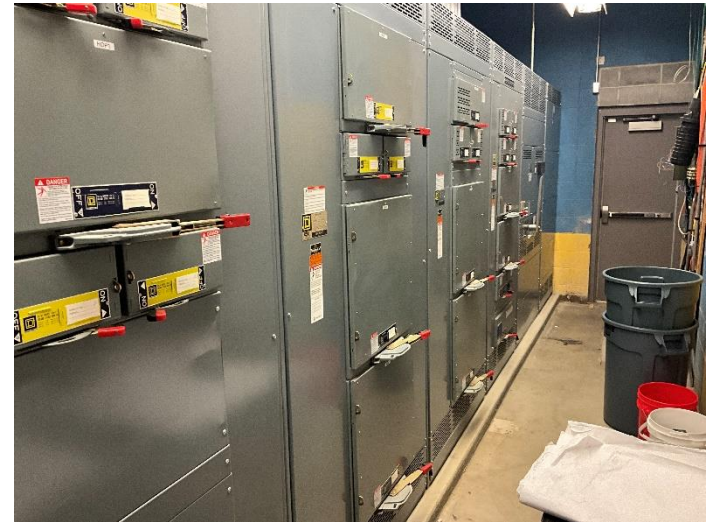
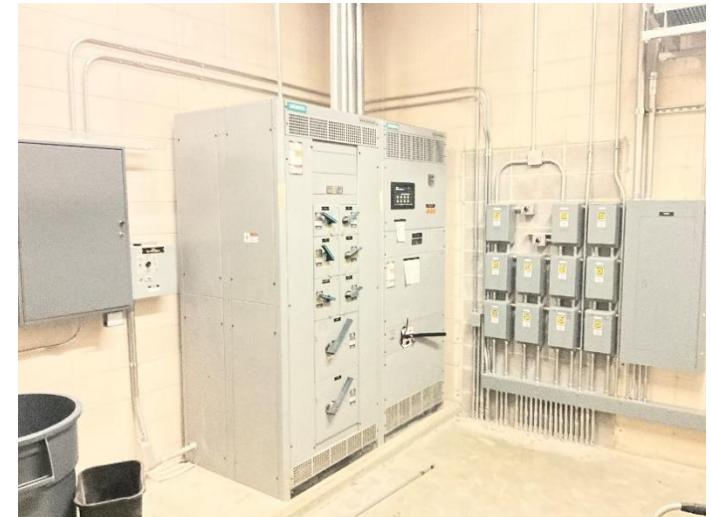
Unit F distribution has one (1) 800A-amp 480/277 Volt 3-phase distribution panels with 800-Amp main circuit breaker that serve branch circuit panels, rooftop units, and dry type transformer. here appears to be sufficient space in the distribution Panel to

add additional circuit breakers. The panels appear to be in good condition and are still serviceable. The panel should have 30-40 years of service from 2004 based on proper exercise of the circuit breaker.

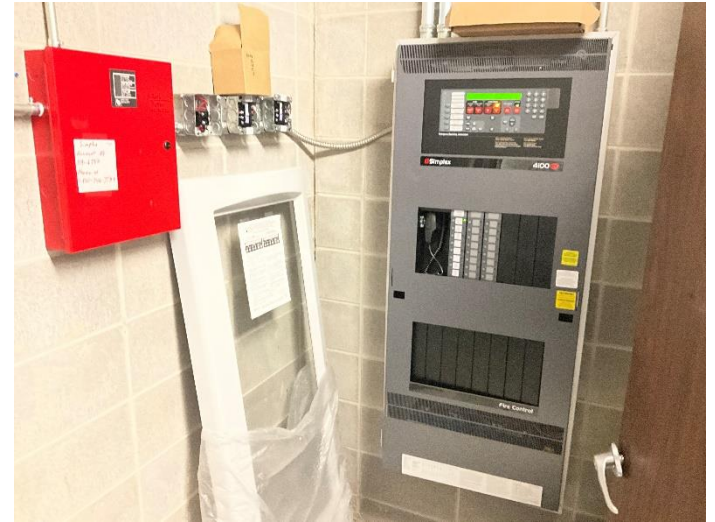
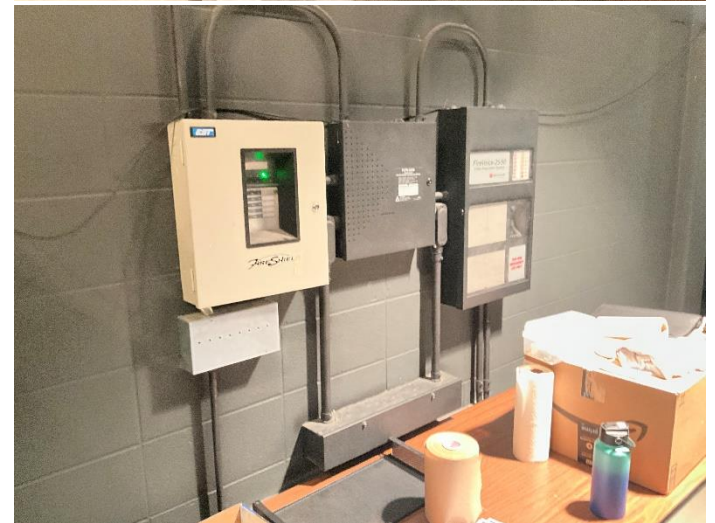
The fire alarm system is being replaced in the summer of 2023. The new system is a Simplex 4100ES series voice evacuation system which is the most up to date system that can be installed. The system shall be good for 10-15 years before system parts and updates become less accessible.

The auditorium has an existing voice evacuation system and the assumption it will be replaced with the updated fire alarm system installed during summer of 2023 project.

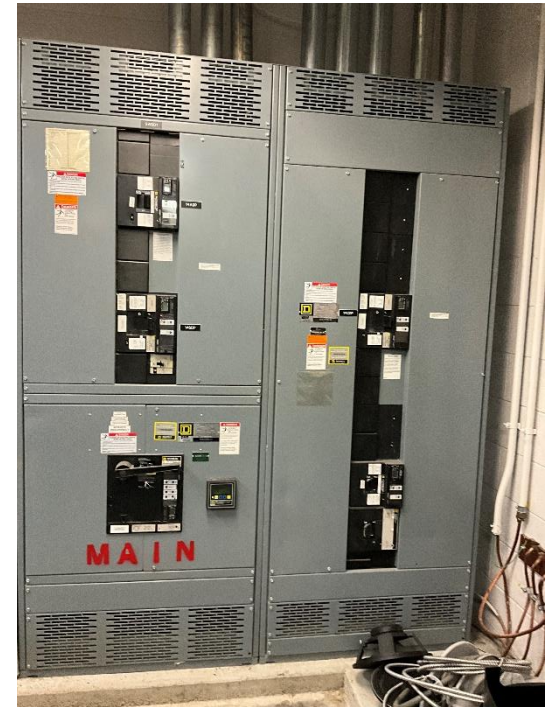
Unit C Electrical room has one (1) 800-amp 480/277 Volt 3-phase distribution panel that serves branch circuit panel, mechanical equipment, trash compactor, and dry type transformer. There appears to be sufficient space in the distribution Panel to add additional circuit breakers with one (1) 200A/3P spare circuit breaker. The panels appear to be in good condition and are still serviceable. 225 KVA dry-type transformer serving one (1)-800-amp 208/120 Volt 3-phase circuit breaker distribution panel with 800A, 3-pole circuit breaker that serves branch circuit panels. There appears to be sufficient space in the distribution Panel to add additional circuit breakers with one (1) 200A/3P spare circuit breaker. The distribution panels are a Square D I-line panel. The panels appear to be in good condition and are still serviceable. The switchboard should have 30-40 years of service from 2002 based on proper maintenance and exercise of the circuit breakers.

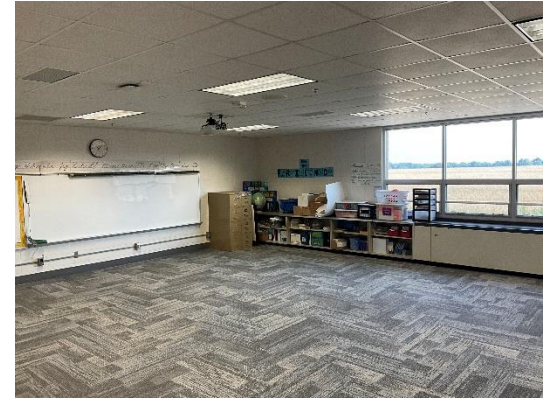
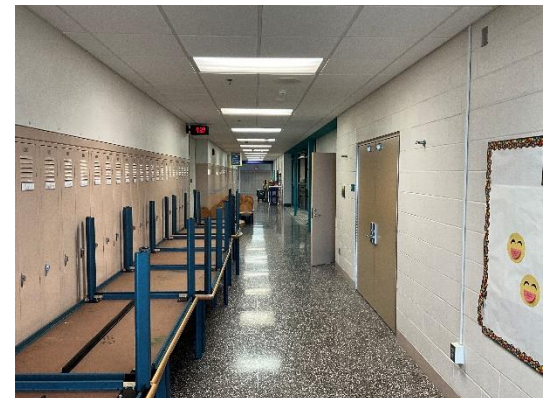
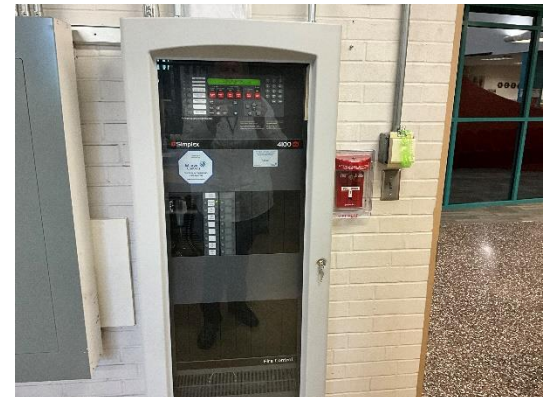
The existing lighting throughout the facility is mostly fluorescent type fixtures with some accent lighting that is incandescent. Exterior Lighting is metal halide style fixture with LED replacement lamps.

First recommend putting forth a replacement strategy to replace all fixtures with new high efficiency LED light fixtures. Since most new LED fixtures are equipped with 0-10v dimming capabilities with 100% to 10% range. Classrooms and offices would benefit greatly from dimming for better lighting control is needed for various activities. Second recommended is to utilized occupancy sensors through the facility to help reduce wasted power consumption when a space is unoccupied. The two recommendations would help reduce overall power consumption that would be reflected in your energy bills. Based on Electrical Service Territories (IURC) on IN.gov. The facility is served by Duke utilities. Duke Indiana offer rebates on replacement of fluorescent lighting to LED.

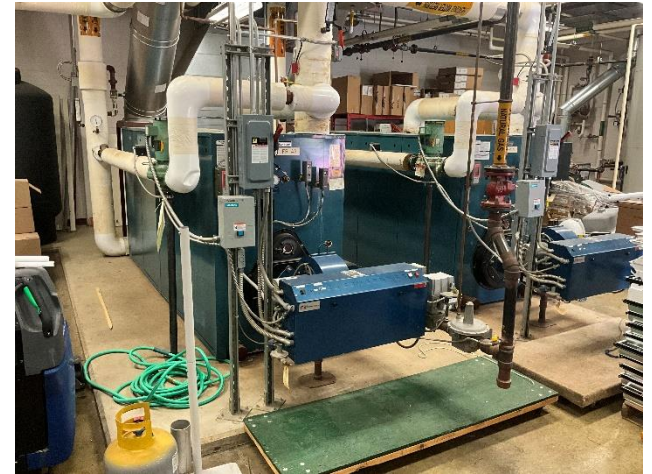
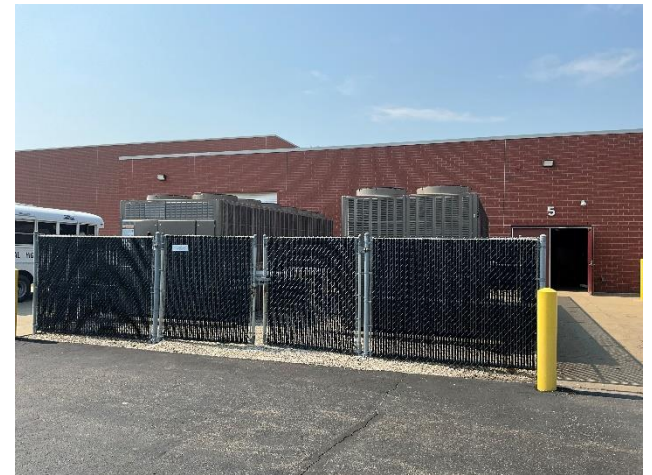
Cooling Plant

The cooling plant consists of (2) York air-cooled scroll chillers with remote evaporator brazed plate heat exchangers, (2) Aurora base mounted centrifugal house pumps, (2) Aurora base-mounted centrifugal chiller pumps, expansion tank, and air-separator. The system was recently upgraded and is in good condition. No improvements are recommended.

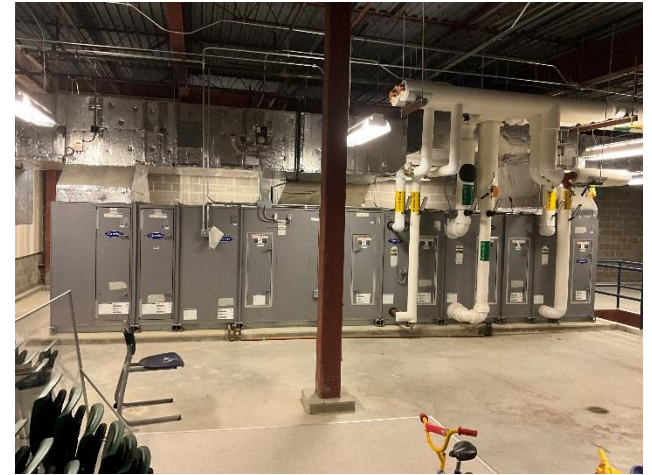
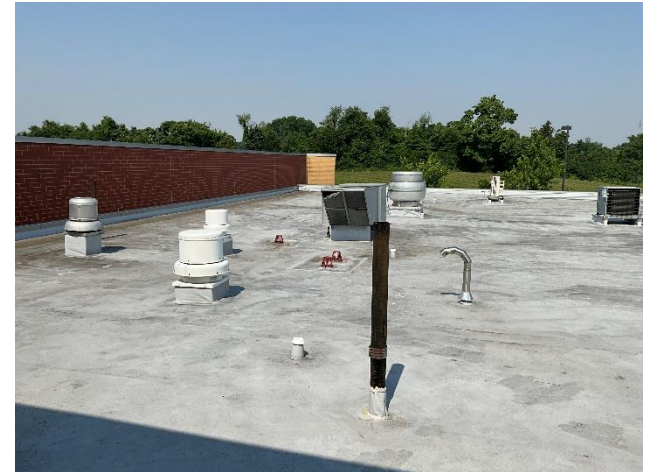
Direct Digital Controls for HVAC

The building control system is a Staefa Controls digital control system. No deficiencies were noted and no improvements are recommended.

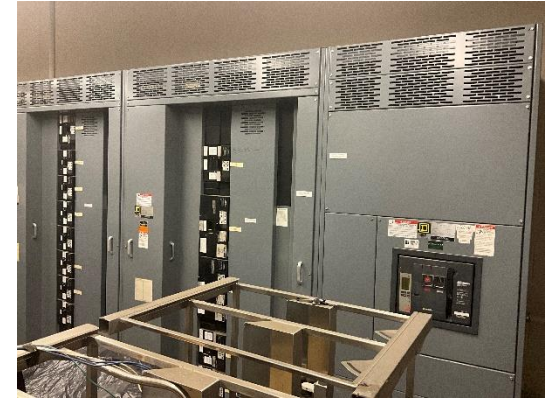
The service entrance switchboard is switchboard is a Square D QED switchboard with 3000-amp Main Circuit breaker with micrologic LED adjustable trip circuit breaker.as the main disconnect. The distribution sections are circuit breaker style that feed distribution panels, a branch circuit panels, dry type transformers (T-4) and two (2) chillers. The switchboard does have a meter and surge suppression that appears to be operating. There appears to be sufficient space in the switchboard to add additional circuit breakers. The main switchboard appears to be in good condition and is still serviceable.

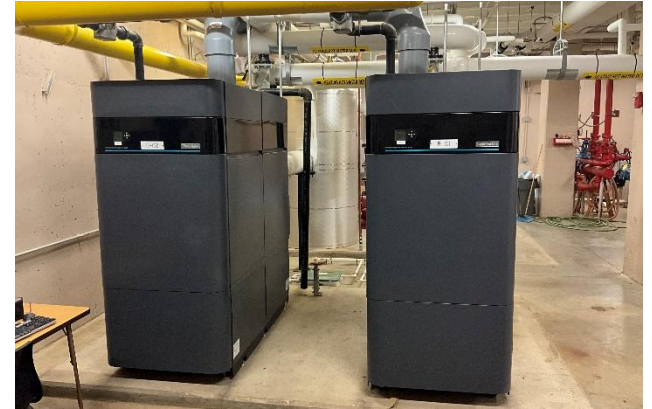
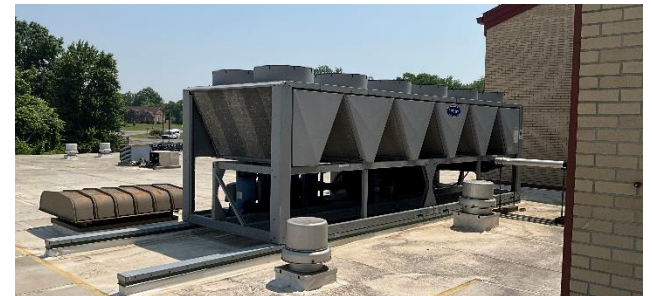
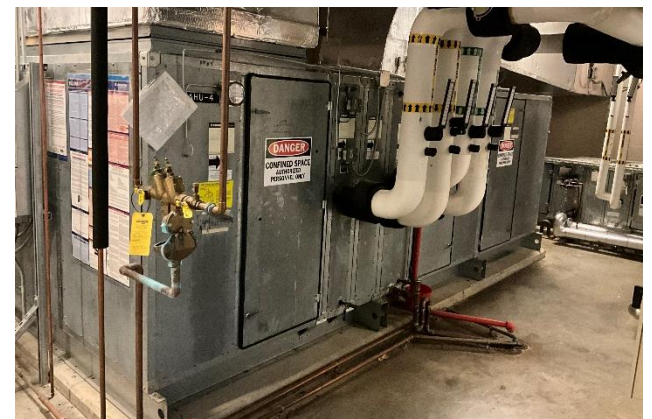
Mezzanine Air Handlers

There are (4) Trane semi-custom modular air handlers located in the Mezzanine. The air handlers have a mixture of hot water coils for heating, chilled water coils for cooling, and DX coils with outdoor condensing units for cooling. The air handling units appear to be original to construction and are near the end of useful service life. **It is recommended that they be replaced.** The outdoor condensing units ACCU-1 and ACCU-C2 have recently been upgraded and are in good condition.

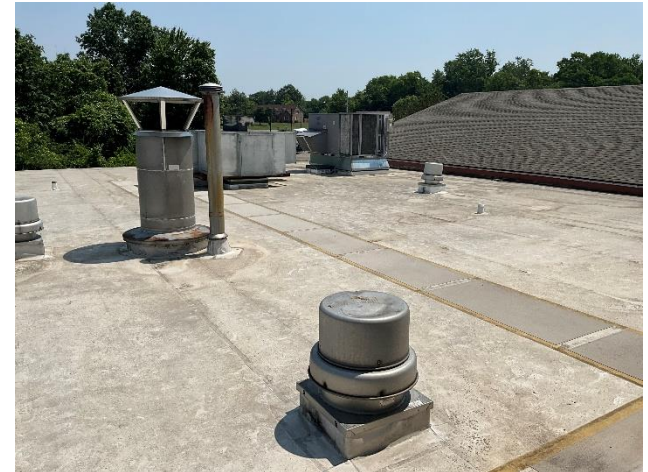
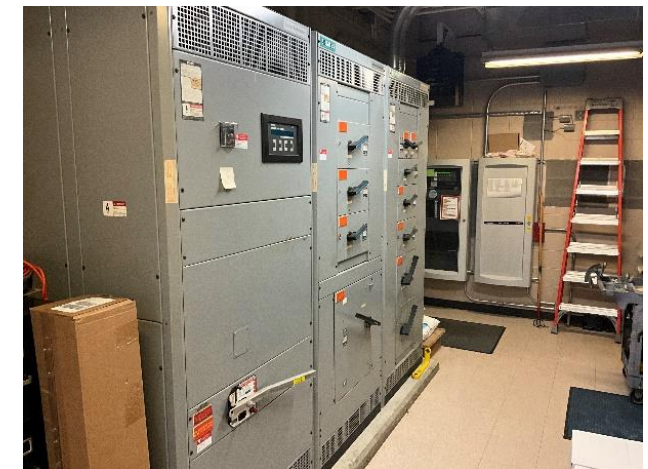
The main electrical room has a 112.5 KVA dry-type transformer serving one (1) 400-amp 208/120 Volt 3-phase circuit breaker distribution panel serving panels in unit C, dimming system, and the kitchen areas. There are one (1) 60A, 3-pole and one (1) 100A, 3-pole circuit breakers that appear to be spare. The distribution panel is a Siemens type S4 panel. The panels appear to be in good condition and are still serviceable. The panel should have 40-50 years of service from 1994 based on proper exercise of the circuit breaker.

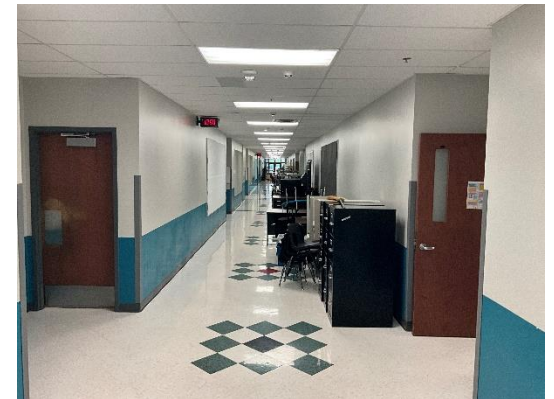
Emergency Egress Lighting in Gymnasium, mechanical, Electrical Spaces utilized Wall mounted emergency Egress lighting. Emergency egress lighting in spaces such as hallways, cafeteria and restrooms is connected through emergency power inverter (4.2kW). These fixtures are operational 24 hours per day 7 days a week. Emergency Power Inverter was replaced in March of 2018 per document on unit. Typical Lead Acid Batteries last 5-7 years.

First recommend putting forth a replacement strategy to replace all fixtures with new high efficiency LED light fixtures. Since most new LED fixtures are equipped with 0-10v dimming capabilities with 100% to 10% range. Classrooms and offices would benefit greatly from dimming for better lighting control is needed for various activities. Second recommended is to utilize occupancy sensors through the facility to help reduce wasted power consumption when a space is unoccupied. The two recommendations would help reduce overall power consumption that would be reflected in your energy bills. Based on Electrical Service Territories (IURC) on IN.gov. The facility is served by Duke utilities. Duke Indiana offer rebates on replacement of fluorescent lighting to LED.

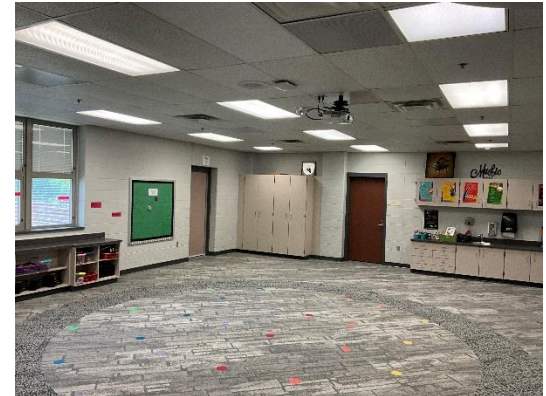
The fire alarm system is being replaced in the summer of 2023. The new system is a Simplex 4100ES series voice evacuation system which is the most up to date system that can be installed. The system shall be good for 10-15 years before system parts and updates become less accessible.

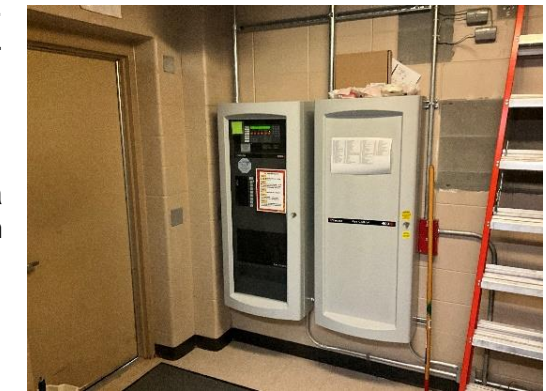
The educational intercom system is being replaced in the summer of 2023. The new system is a Bogen Nyquist system which is a hybrid digital-analog system which is the most up to date system that can be installed.
